# Importance of Structural Integrity in Precast Connections

**Dr. N. Gopalakrishnan**

National Workshop on Prefabricated Buildings and Construction, Hyderabad – Nov-2021

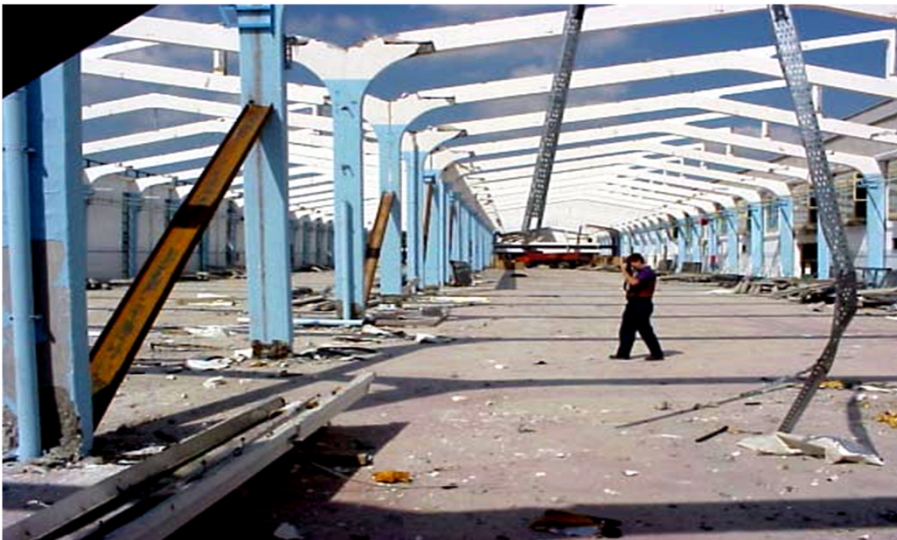
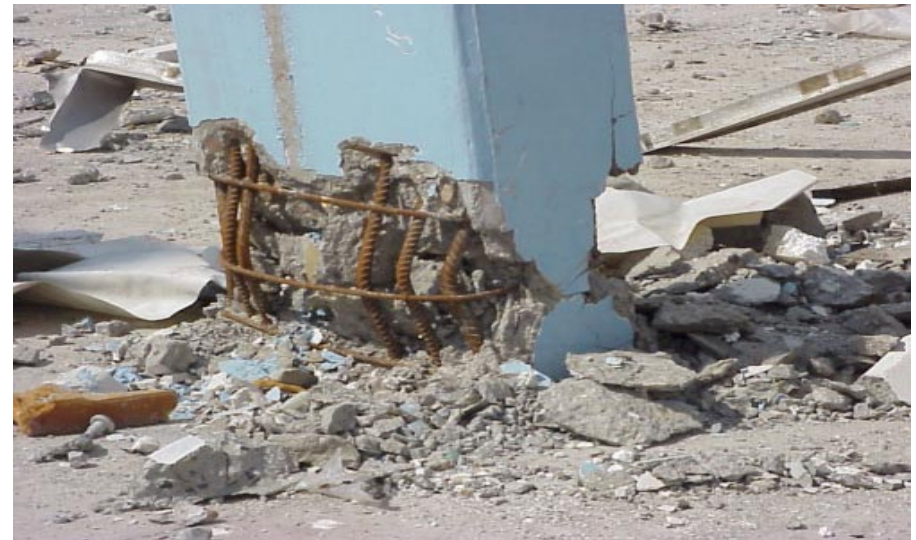
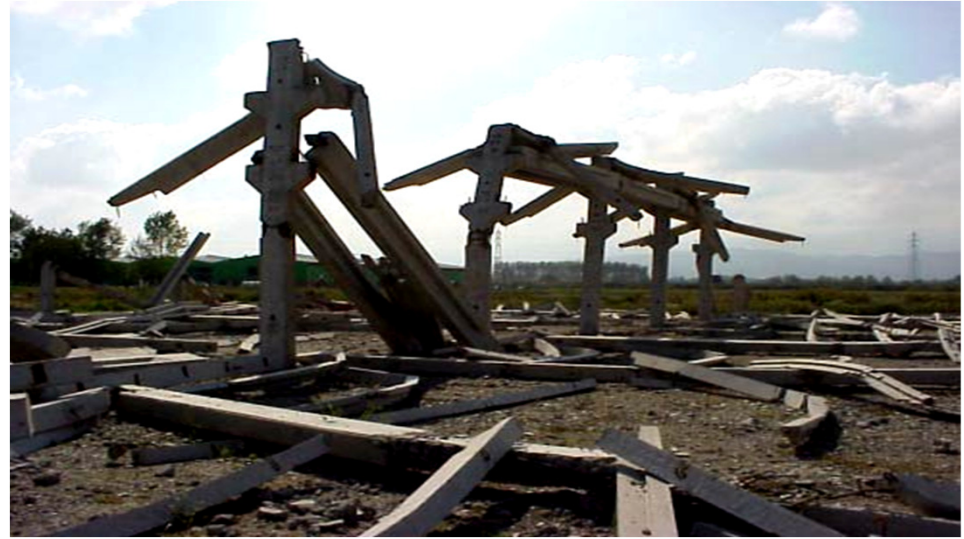
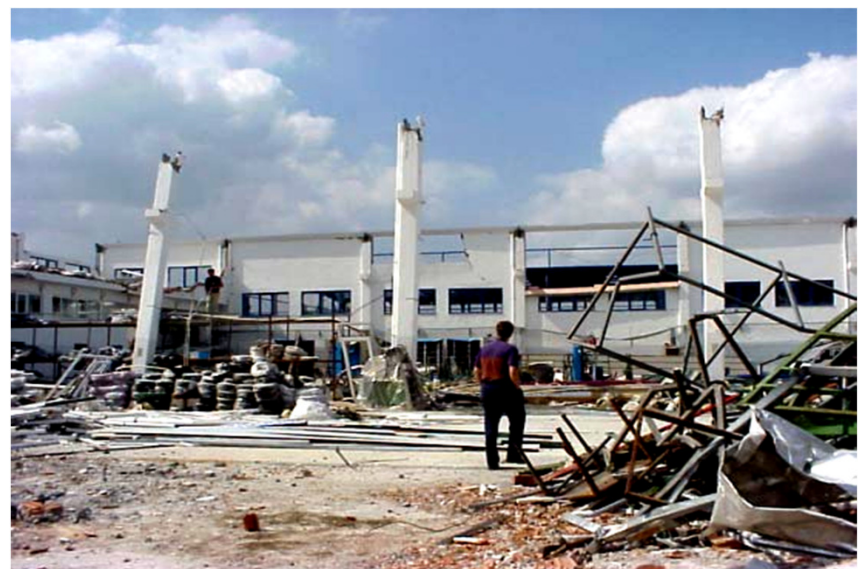
## Kocaeli (Turkey) Earthquake of Magnitude 7.4 - August 17, 1999

Large deformation of precast columns in the structure paved the possibility of formation of flexural hinging near the column base making it **inefficient to dissipate energy** causing the column to fail.

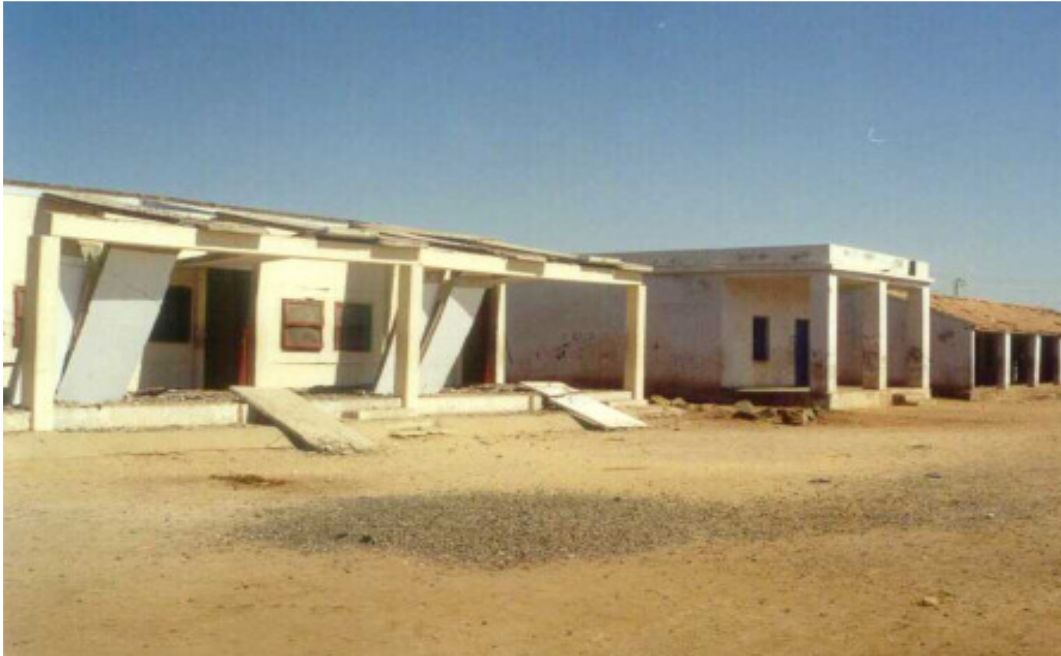
## Bhuj Earthquake - January 26, 2001

Inadequate **connection** between the roof panels.

Insufficient **seating** and **anchorage** of roof panels over the walls and beam.

These inadequate property led to **lack of floor-diaphragm** action causing dislodgement of roof panels from the atop of the building.

The adjacent cast-in-situ RC building performed well during the earthquake describing the detrimental effect of connection role in seismic regions.

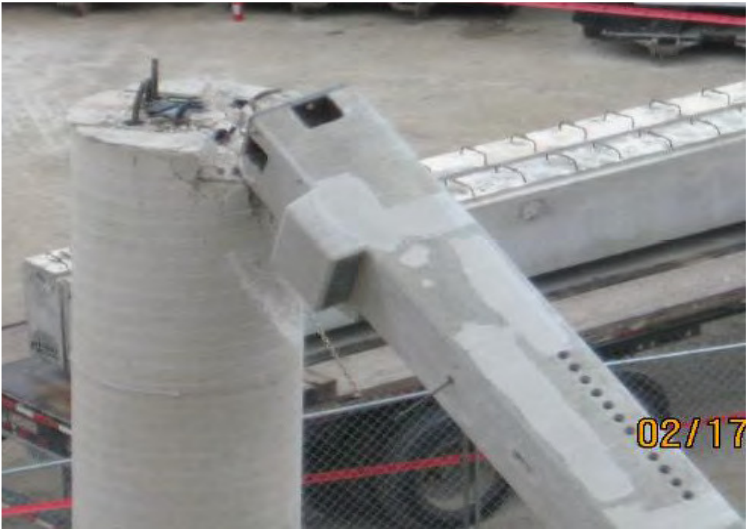
- Flawed construction of contractor to provide proper support for the precast column base plates due to a lack of grout underneath the base plates.
- Uneven displacement of the nuts caused the columns to tilt, resulting in the collapse.

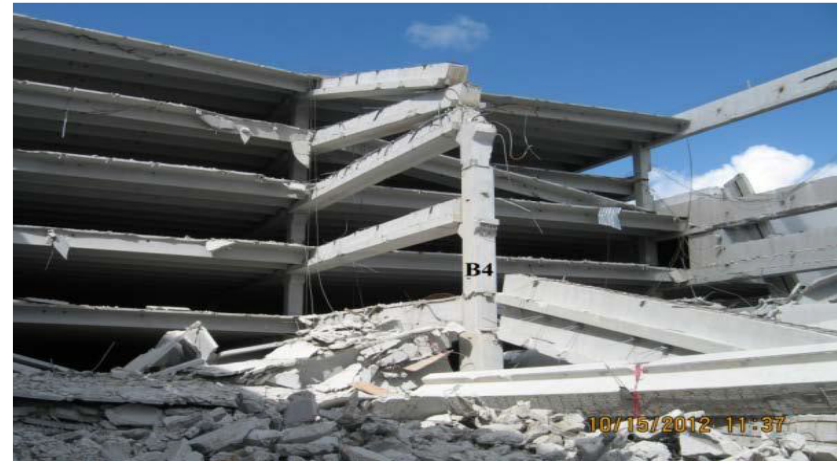
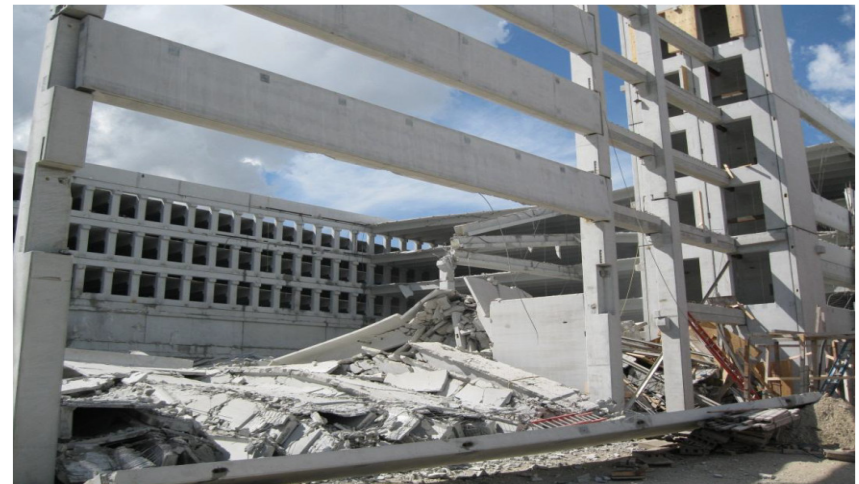
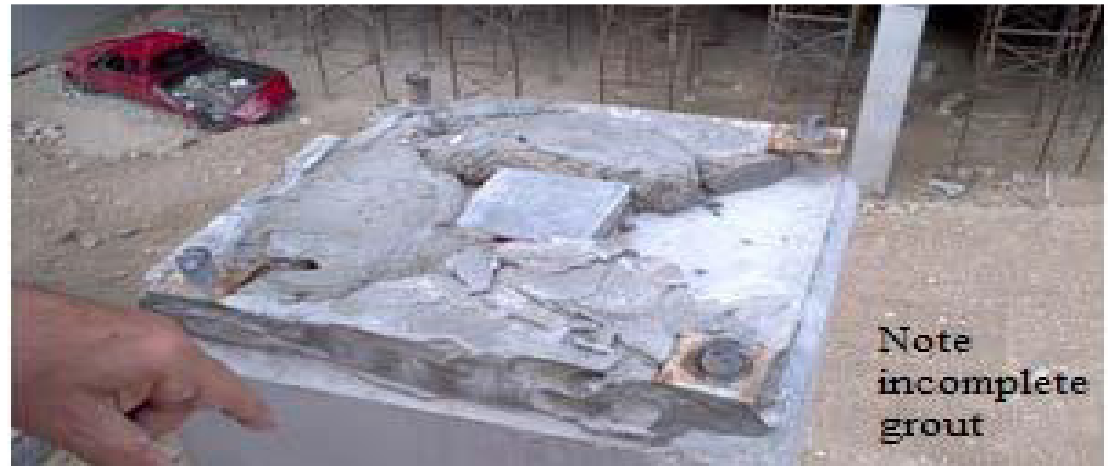
- Poor grouting placed between the column and the footing.
- The increased load on the interior column exceeded the anchor bolts and shim plates capacity.
- When the interior column collapsed, a cascade effect was initiated that led to other columns, inverted tee beams, and double tees to collapse.
- Precast structural members were not adequately supported by welding and bracing (29 CFR 1926.704(a)). These deficiencies added to the structural instability.

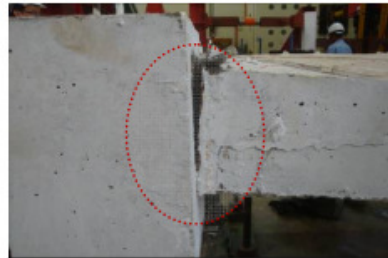
Welding Broken between Headed Stud  
Steel Anchor and Steel Plate

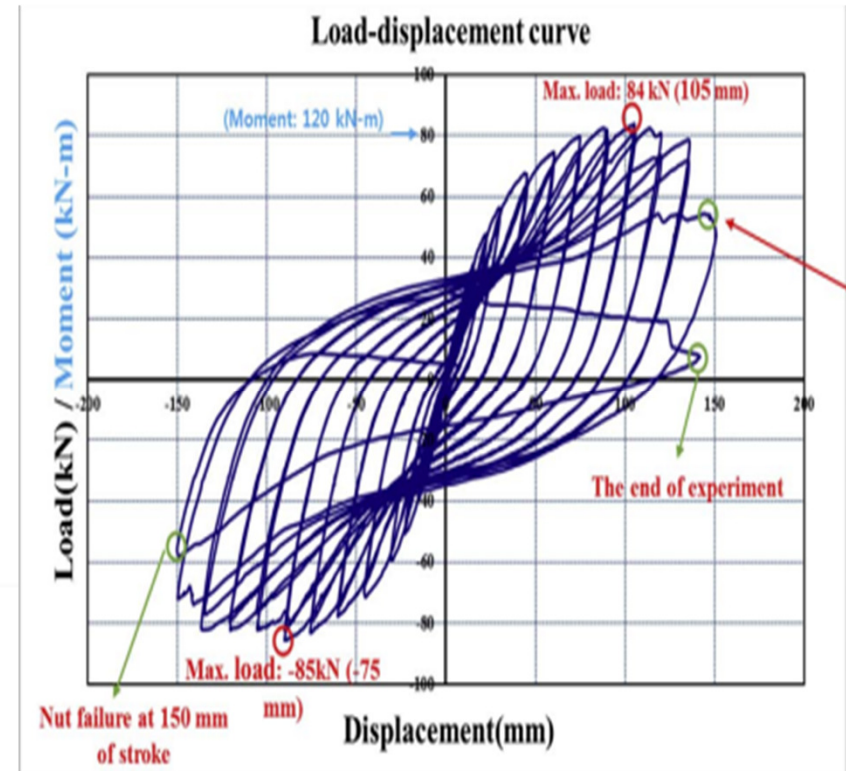
M. Breccolotti et al. (2016) proposed a wet joint Beam-Column connection in which the experimental results confirmed its good structural performances in terms of strength and ductility.

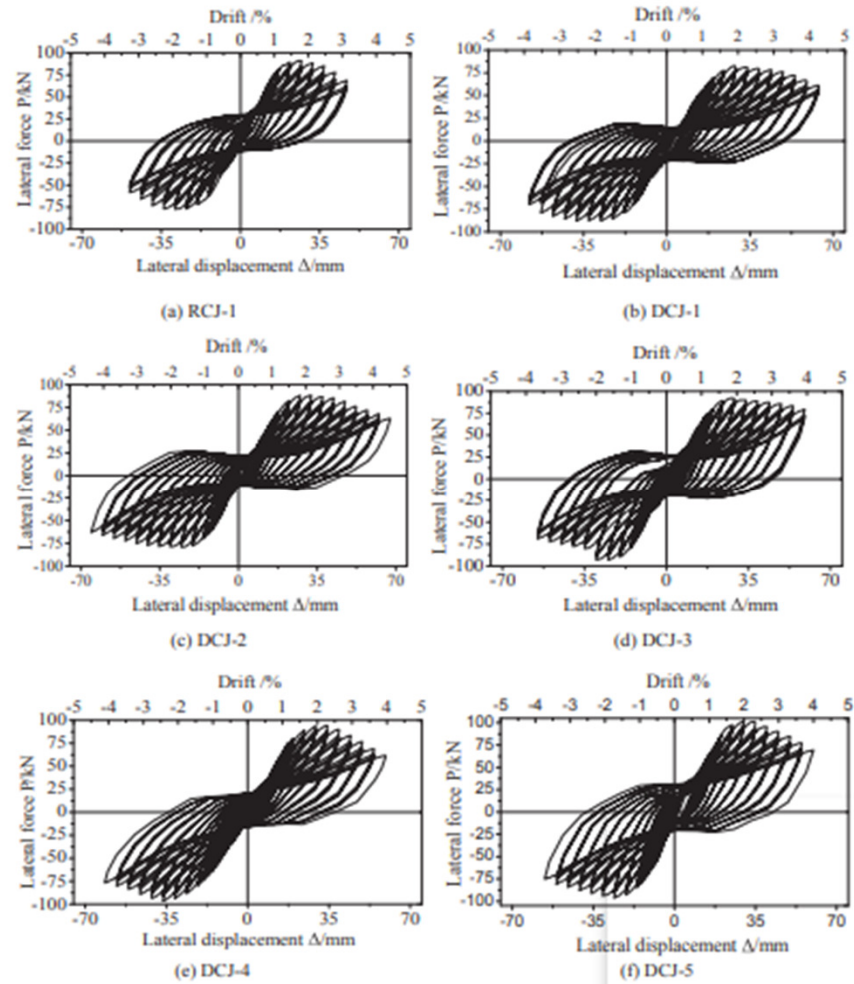
R. Sousa, et al.(2020) highlights the important contribution of the dowels for the total lateral strength, as well as the need to incorporate the friction component in order to obtain a reliable estimate of the energy dissipation of a connection system .

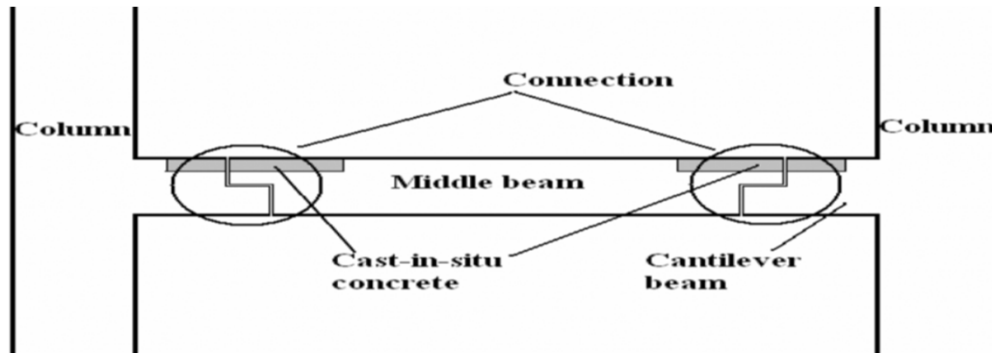
Hasan et al.(2005) did investigation on the cyclic performance of precast concrete beam-to-beam connection by use of conventional and welding techniques and did comparisons with a monolithically cast specimen.

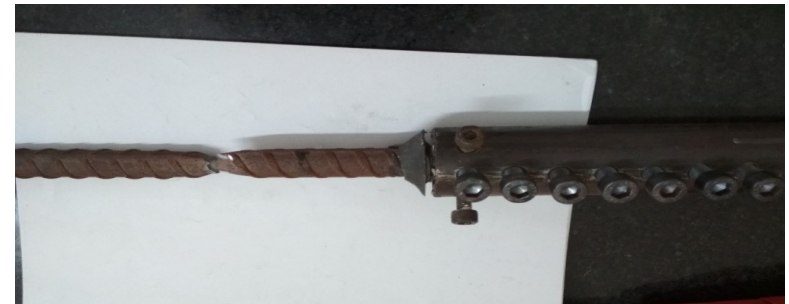
- Rebar Coupler is the primary source to connect the adjacent rebars. In particular this connection is proposed in the hinge region. Hence this has to connect the rebars and able to dissipate energy under cyclic loading.
- Hybrid rebar coupler for various diameter bars have been fabricated and tested under tension to estimate the connection tensile strength and failure behavior.
- Based on the test results, modifications in the couplers have been made and second stage specimens have been prepared.

**Tensile Behavior of Rebar with Coupler (20 mm dia.)**

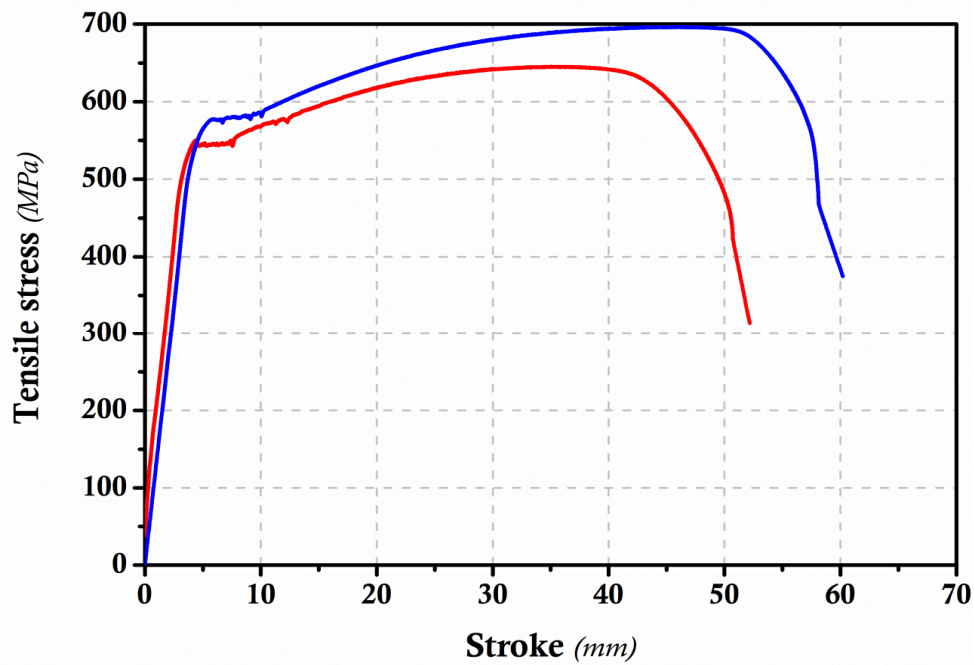
# Tensile Behavior of Rebar with Coupler

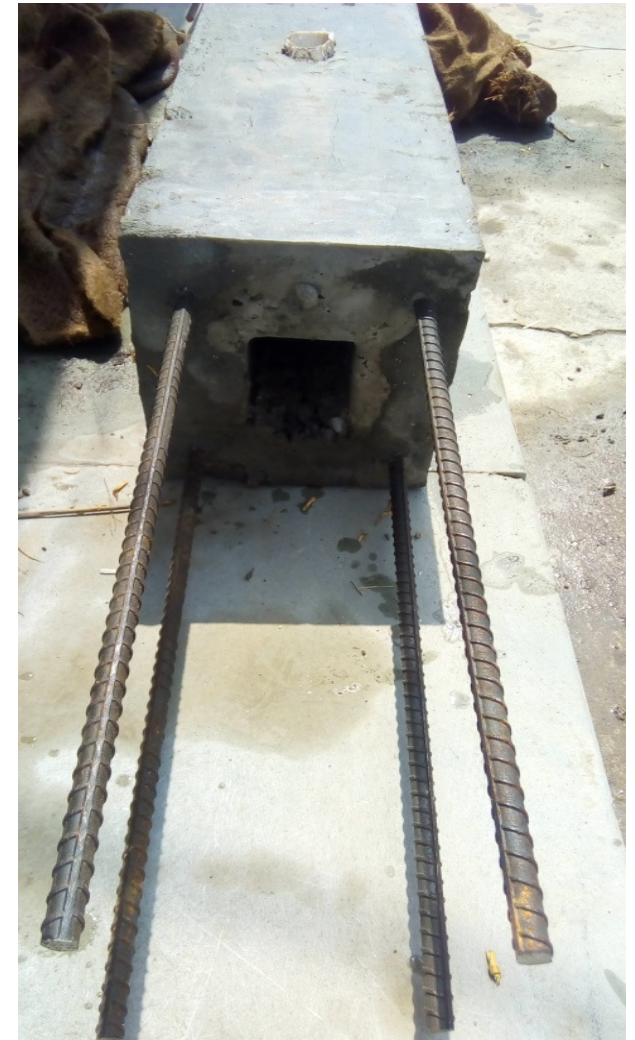
# PRECAST COLUMN WITH HOLLOW CORE PROVISION

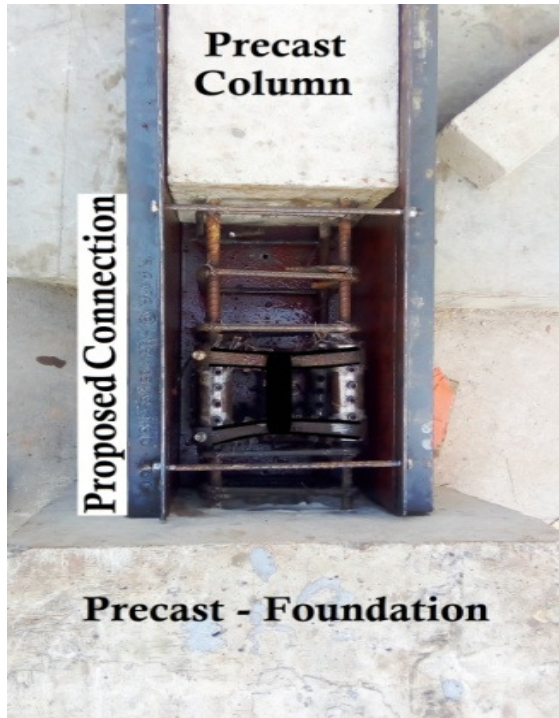
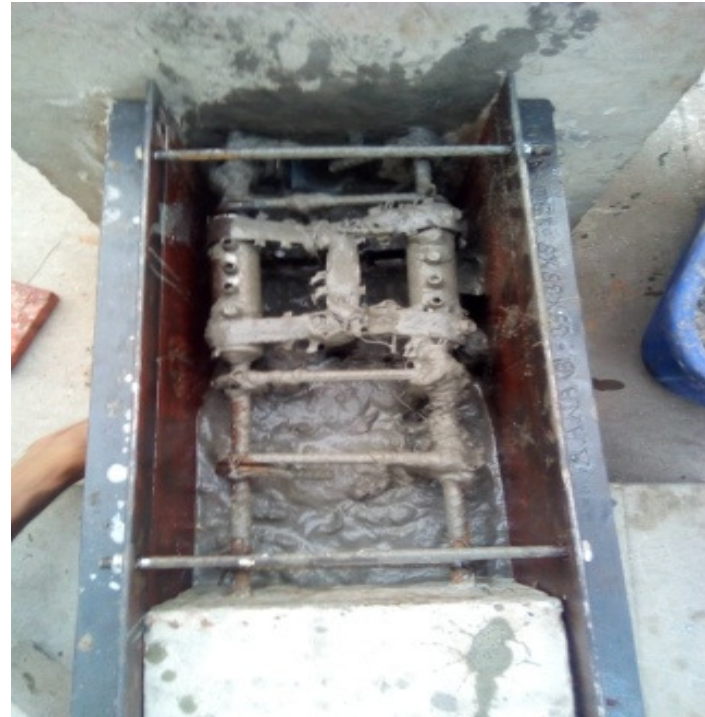
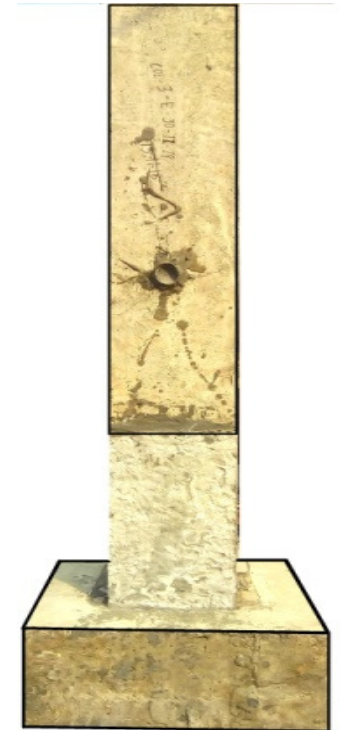
# PRECAST COLUMN WITH HOLLOW CORE PROVISION

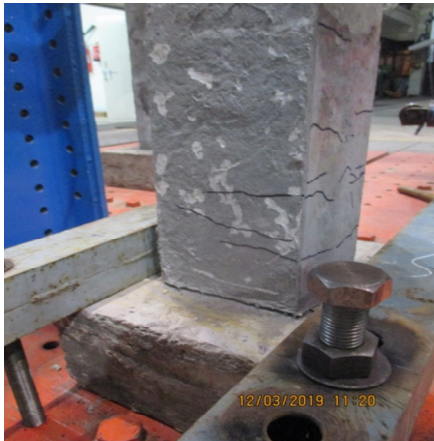
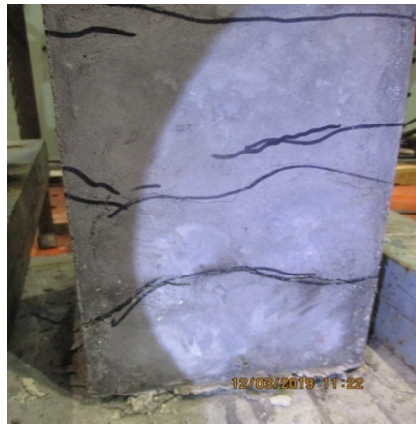
Cracks at the Hinge

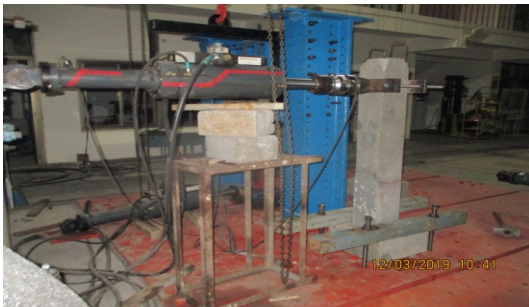
Cyclic Test Setup
